Nine-Element Nonpoint Source Implementation Strategic Plan (NPS-IS plan)

**Blanchard River:
Tiderishi Creek 04100008 05 01
Version 1.0**

Approved: April 5, 2018

Created by:
Blanchard River Watershed Partnership
PO Box 1237
Findlay, OH. 45839-1237
Phil Martin - Watershed Coordinator

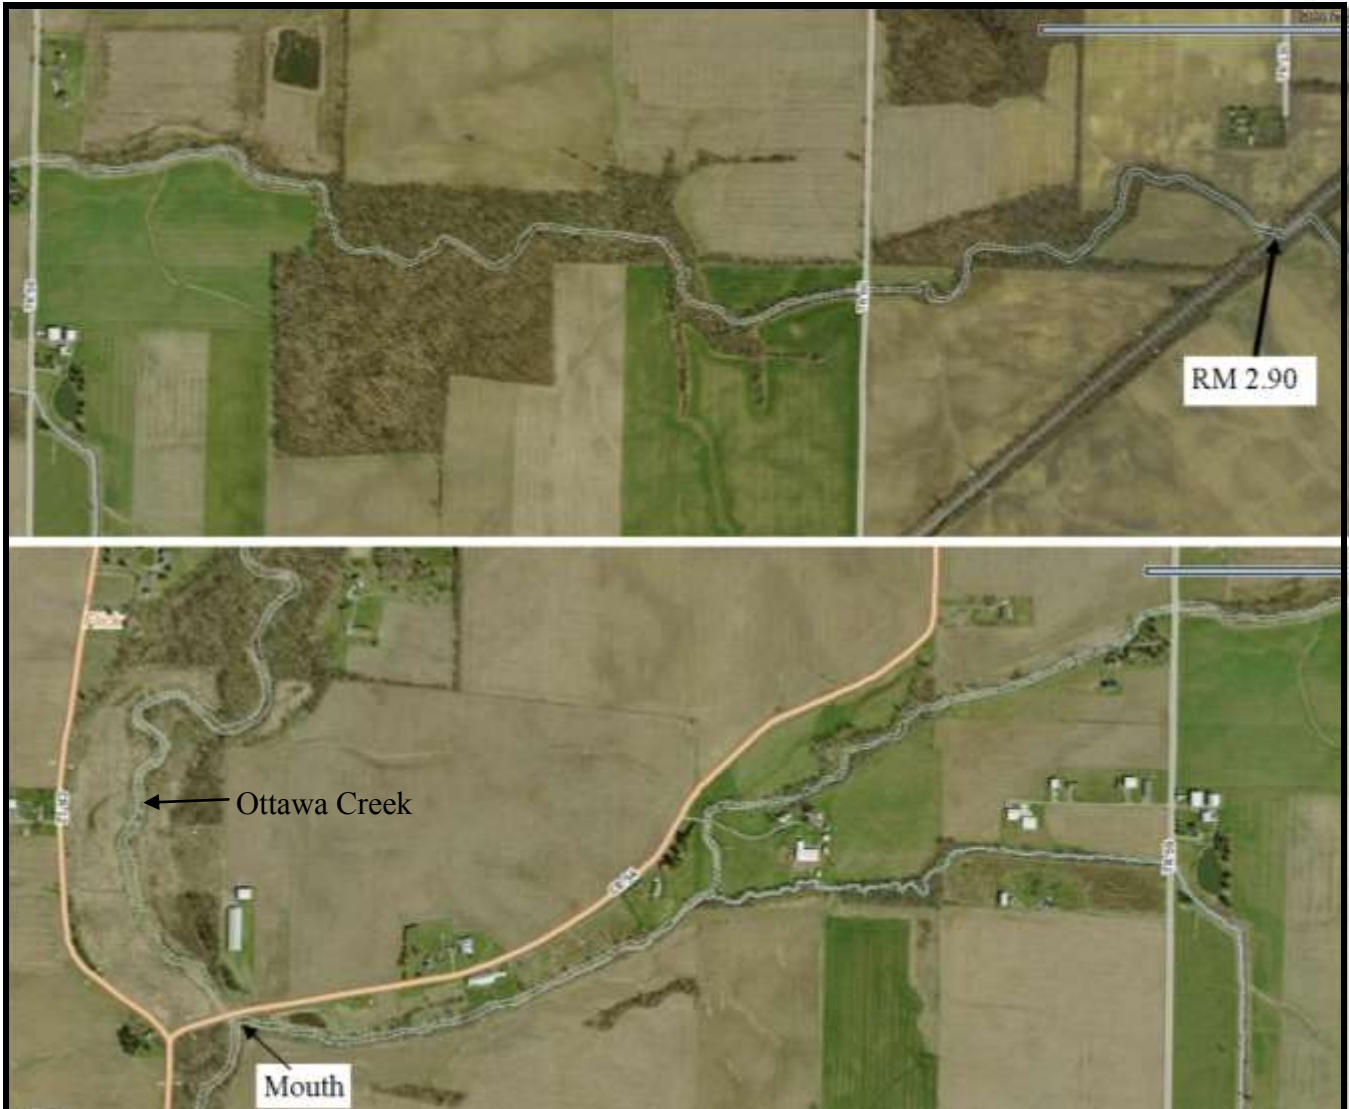
Picture 3.1: Aerial view of the area runs from RM 2.9 at the Norfolk & Western railroad crossing to the mouth with Ottawa Creek. This area was designated as a WWH by 2009 TMDL Report. The aerial view shows a view of what the land adjacent to Tiderishi Creek looks like through most of the creek.

The 2009 Ohio EPA TMDL Study reported on three sampling sites in the **Tiderishi Creek HUC - 12**. The sampling at these sites was done in 2005. The site at RM 0.1 was in partial attainment and was the only site that retained its WWH status after the study. The WWH status extends from the mouth of Tiderishi Creek to the Norfolk and Western railroad crossing at RM 2.90. The TMDL Report on page 56 states, "habitat conditions in the lower reach make WWH attainment a reasonable expectation with lessening of nutrient inputs to Tiderishi Creek." Map 3.1 on the next page provides an aerial view of this area. The aerial view is very representative of the entire watershed.

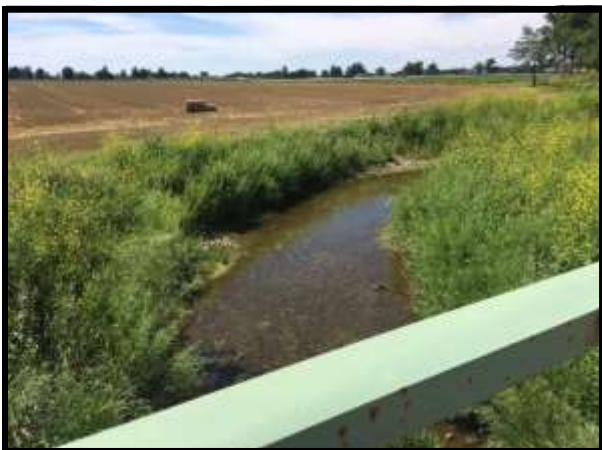
Picture 3.2: The picture shows the typical buffer area along the Tiderishi Creek. The banks contain a combination of shrubs, trees and grassy vegetation.

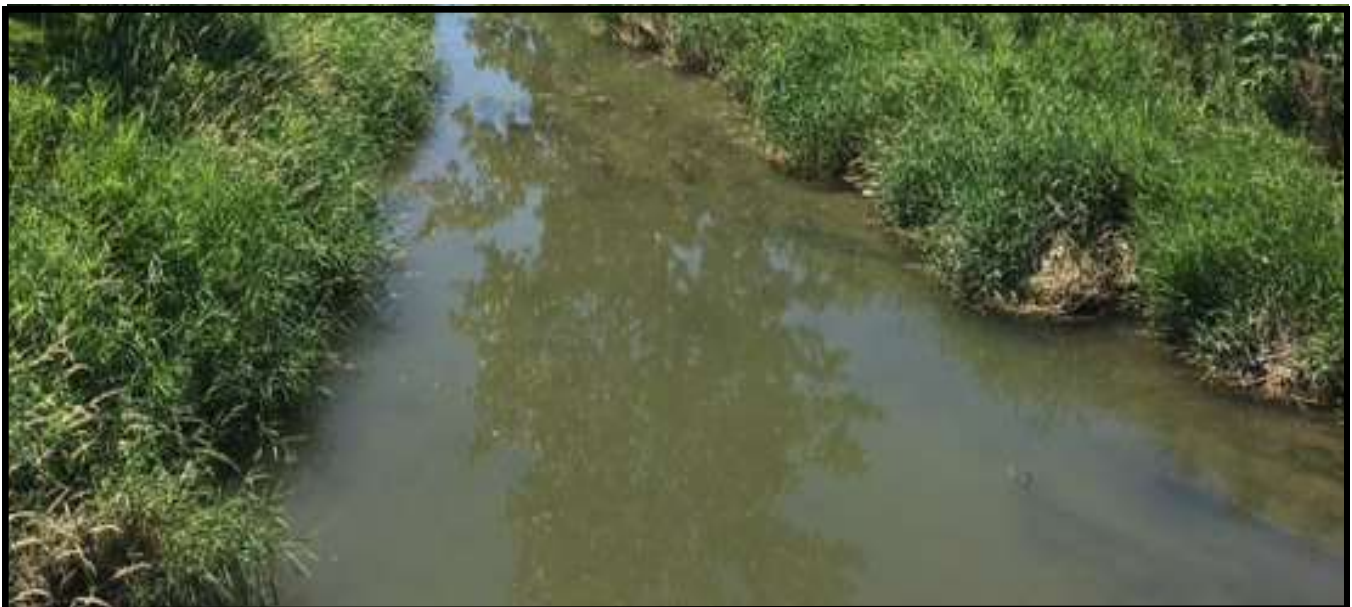
Picture 3.3: The picture shows the sedimentation of the substrate that is common throughout Critical Area 2. The sediment has impaired the habitat of substrate causing the aquatic use to be limited.

Objective 2 will involve using in-stream sediment removal technology to remove the sediment that has accumulated in the substrate the main stem of Tiderishi Creek in critical area 2. Removal of this sediment will improve the condition of the substrate increasing the QHEI, IBI and ICI scores. Removal of this sediment will take a significant planning process that must include lowering the bedload sediment from upstream entering this area. Therefore, this objective will become a medium term (3-7 years) project. Once a plan is developed, a Project Summary sheet will be developed and submitted to the Ohio EPA for approval. ***Note: This BMP is not listed as an eligible §319 practice in Ohio Nonpoint Source Management Plan (June 2014)***
